# Manhole Inspection Summary

Manhole # S31WW\_013MH

Insp Date: **8/27/08 11:33 AM**

**Location** Address: **3122 REMINGTON AVE**

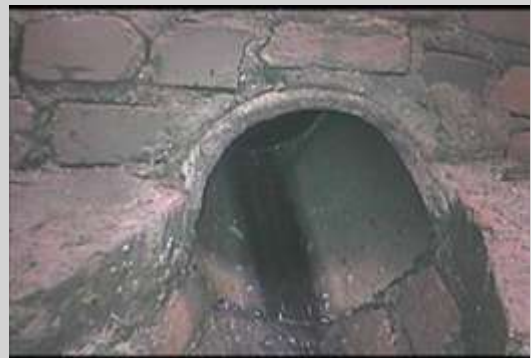
### Drop In @ 3 O'Clock

Drop: **Outside** Rod and Bar

Angled: **Yes** Reading: **6.15** (ft.)

Drop Condition: **Open**
